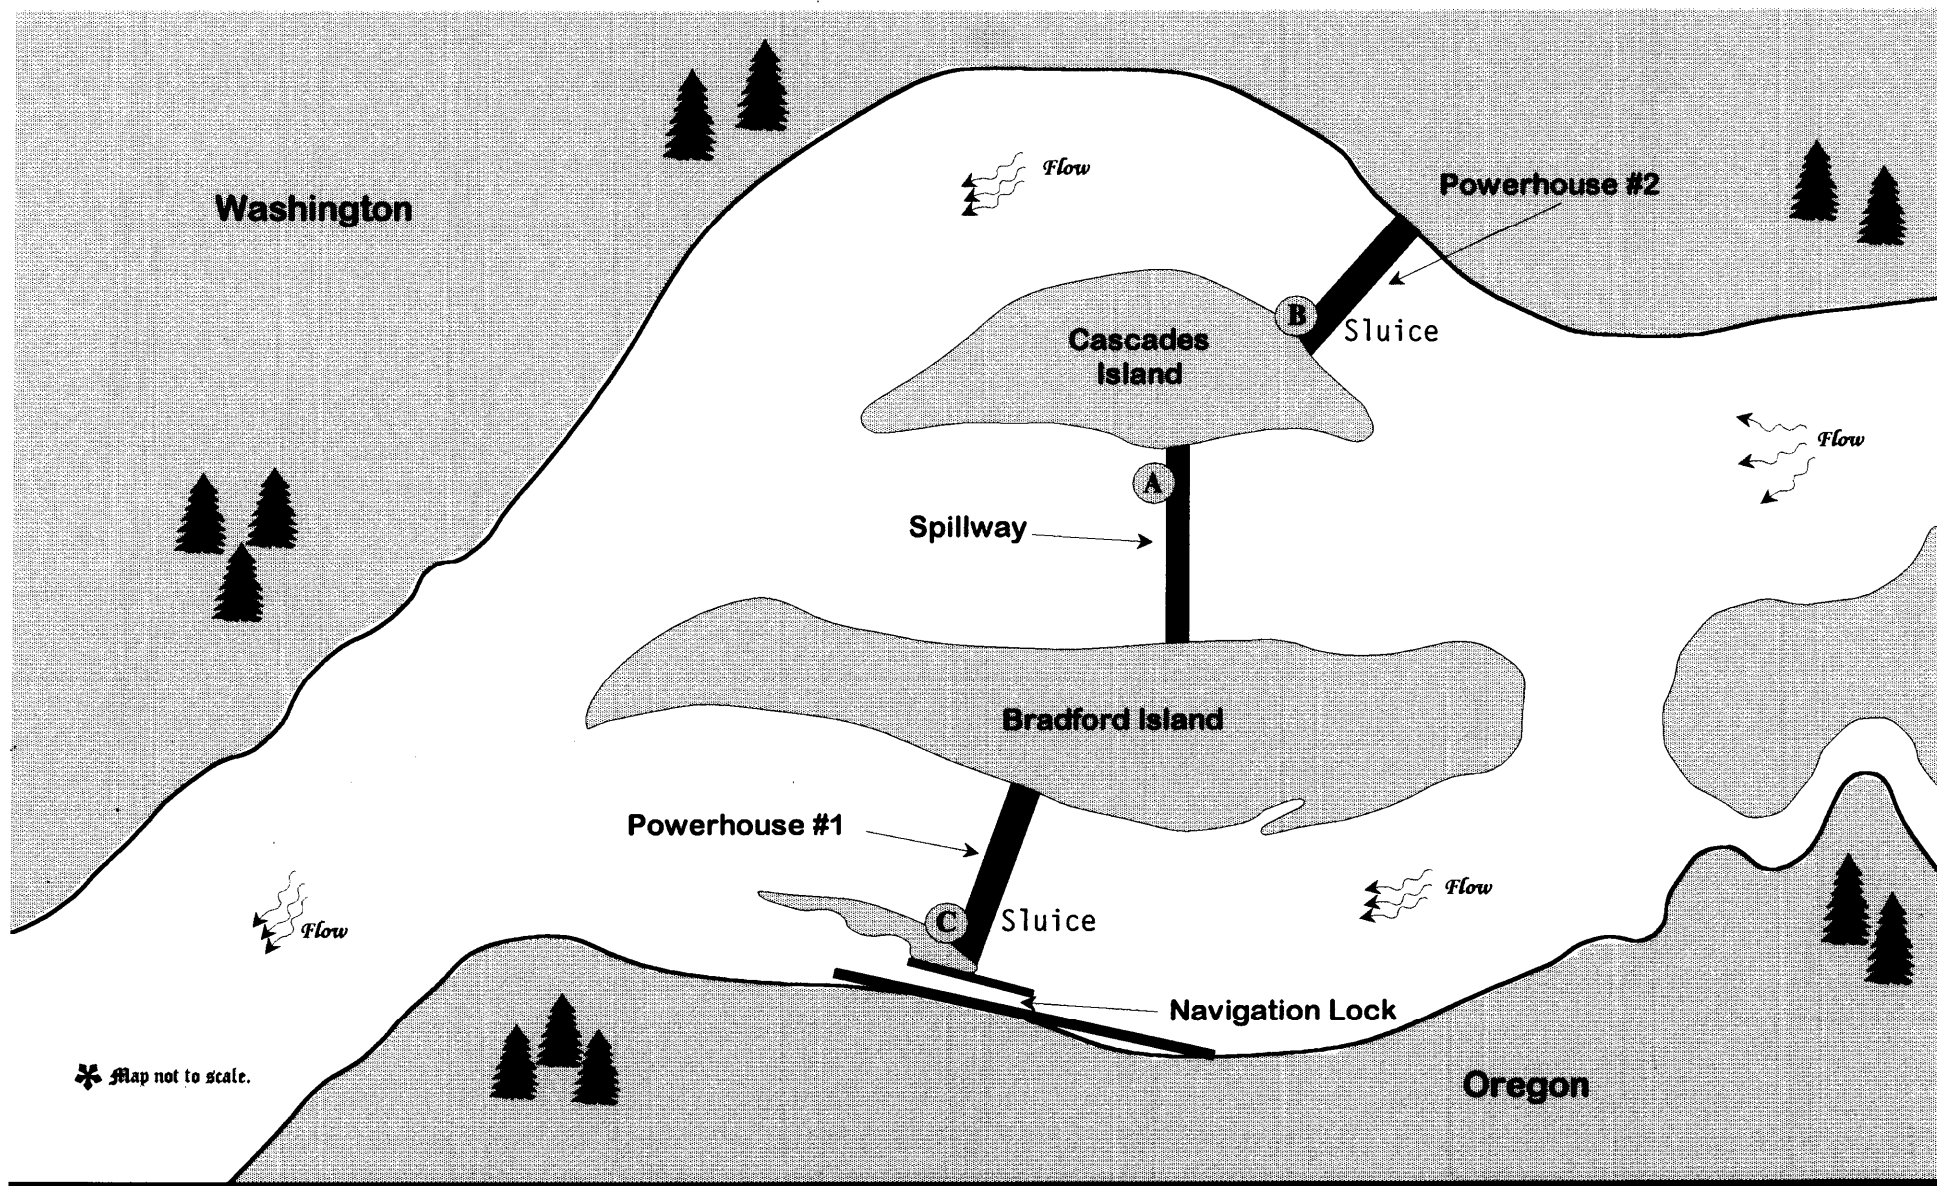
**Figure 1-2**

Area map of the Bonneville Lock and Dam on the Columbia River showing the three sites where juvenile salmon were assessed for condition after passage through spillbays (A), sluice at Powerhouse 2 (B), and sluice at Powerhouse 1 (C).
